When an aging spill control device began working less efficiently and its reliability faltered in recent years, it was deemed no longer cost-effective to refurbish.

Against this backdrop, IBS was engaged to design, manufacture and install a new spill control solution, in order to provide isolation of flows from the surface outfall of this large medical manufacturing plant.

Sector:
Healthcare

Client:
Scapa Healthcare

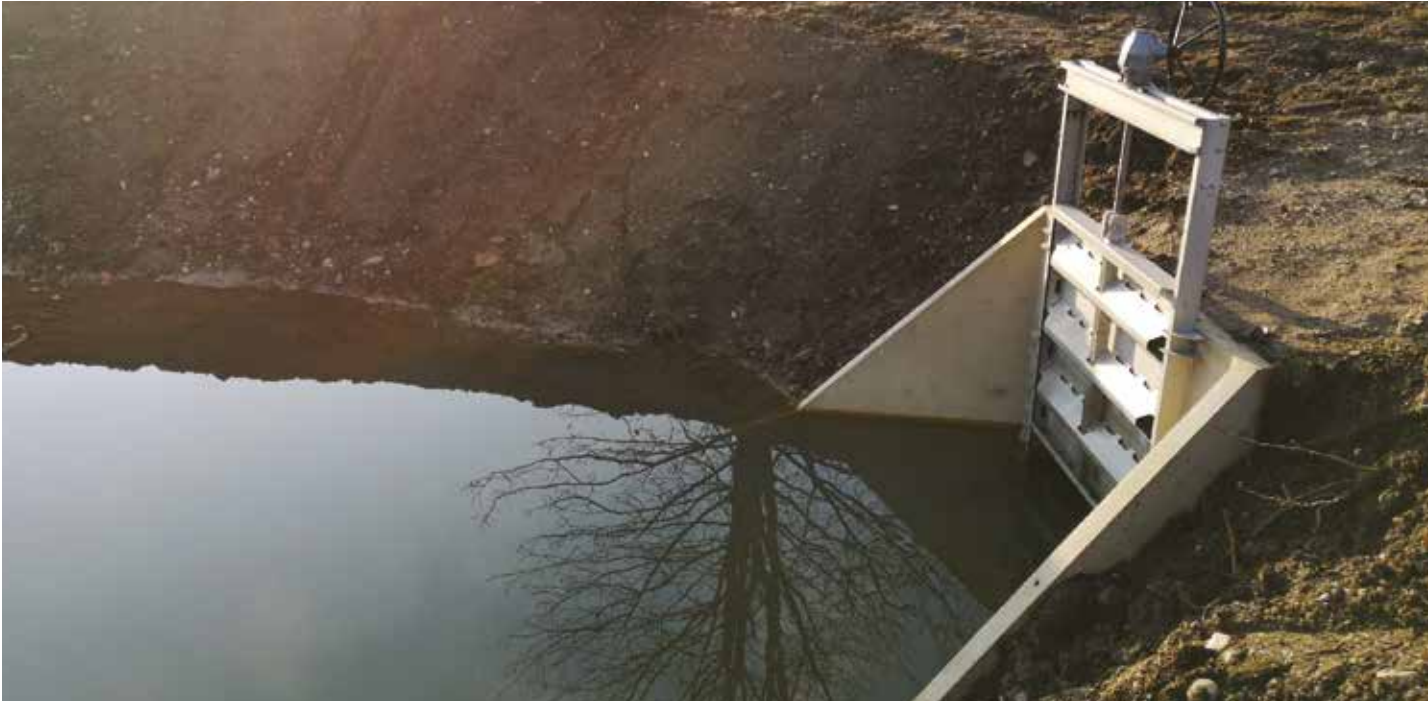
The IBS solution was to install a new 1200mm x 1200mm stainless steel penstock – a type of flow control device used to isolate or control the flow of water – at the downstream end of the existing outfall pipe. However, due to the absence of an existing structure to fix to, a pre-cast concrete headwall was built into the design. The project was not without its

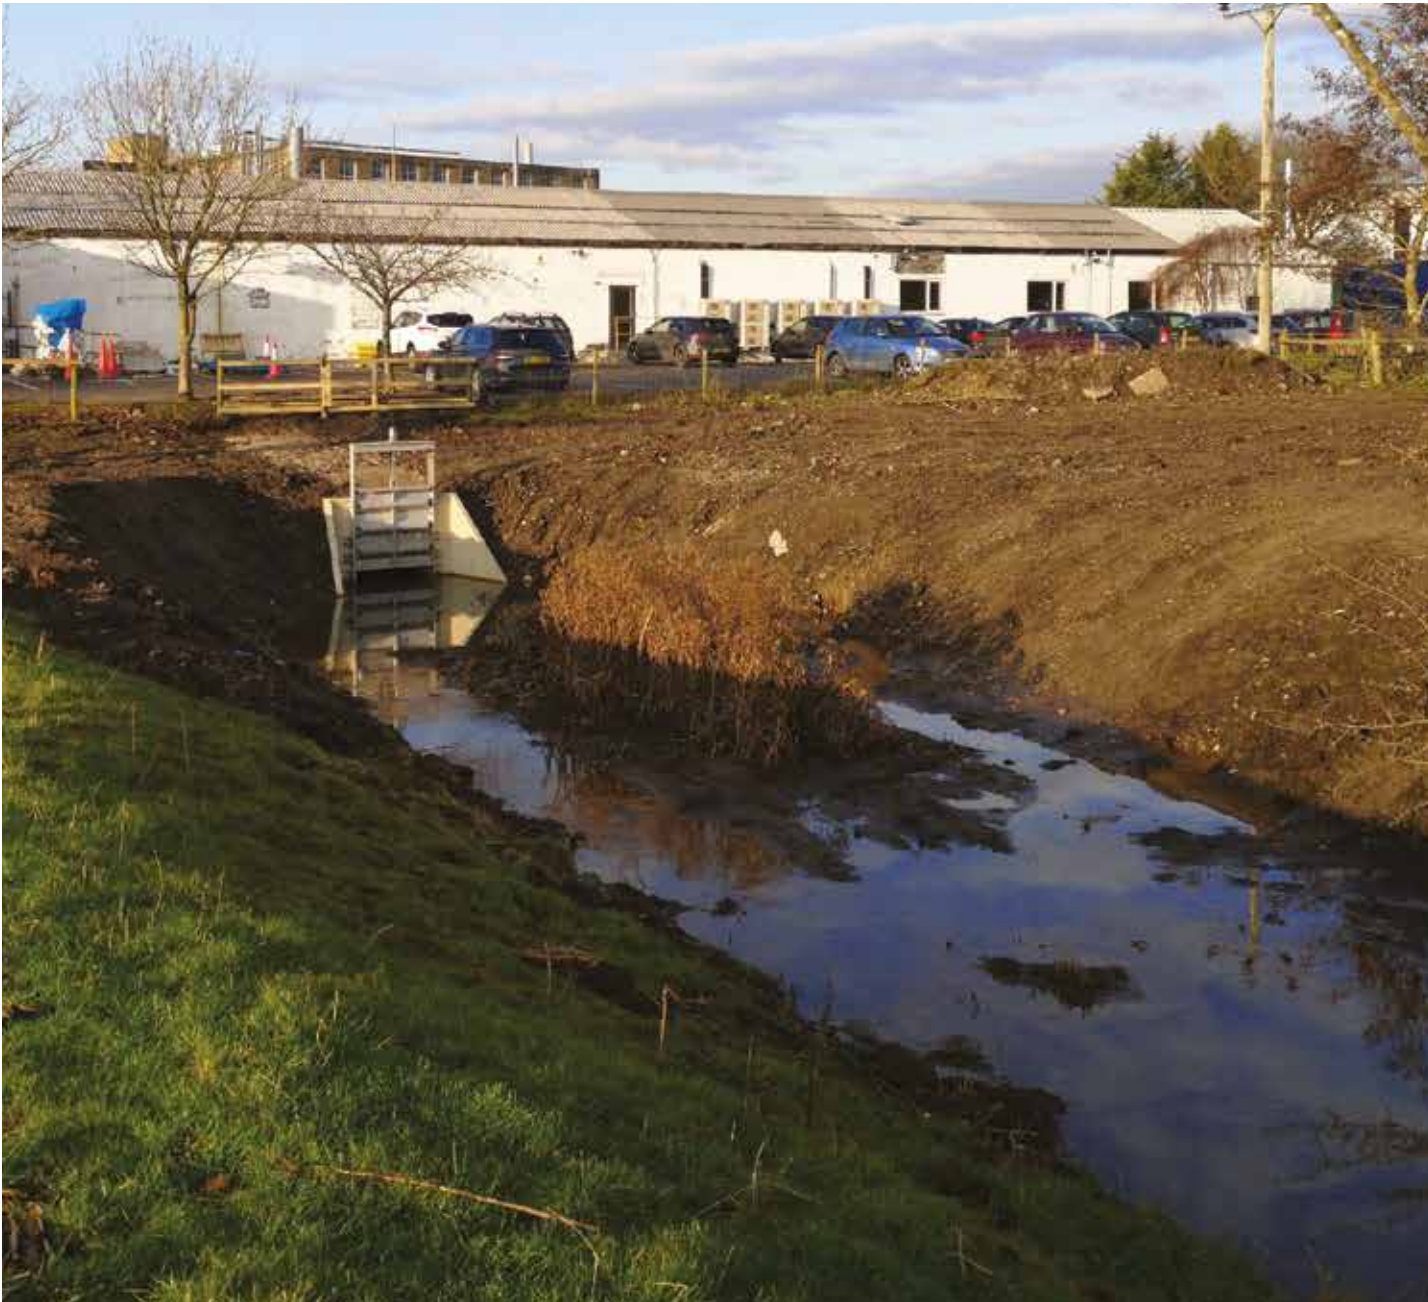
Product/s:
Stainless Steel Penstock and Auma Gearbox

Size:
1200mm x 1200mm

With the over-pumping system in place, the enabling works could then be completed, which allowed the concrete headwall and stainless steel penstock to be installed. Once complete, commissioning was carried out to the total satisfaction of the
